Radiator Grille Store

C8 CORVETTE STRUT TOWER COVER INSTALLTION

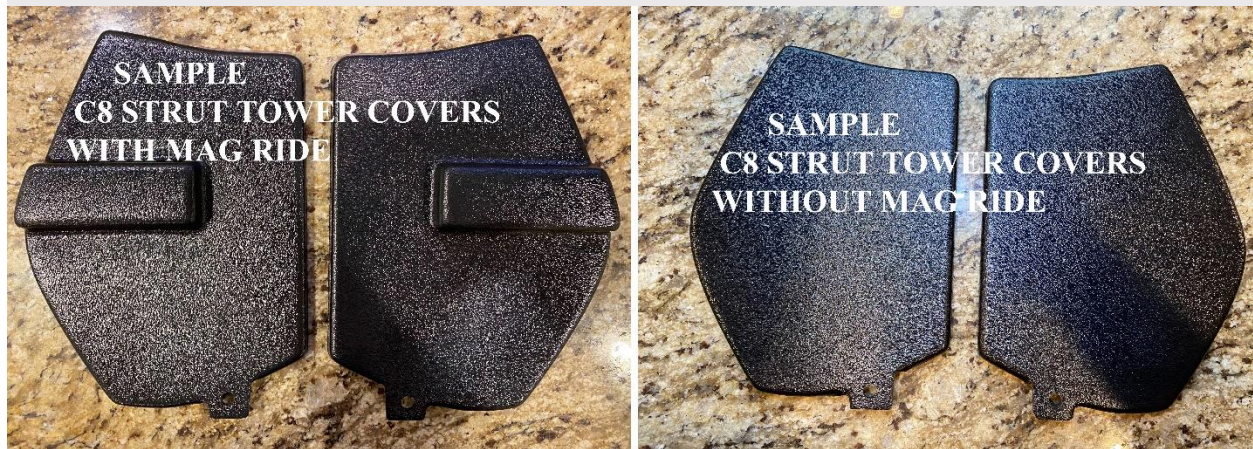
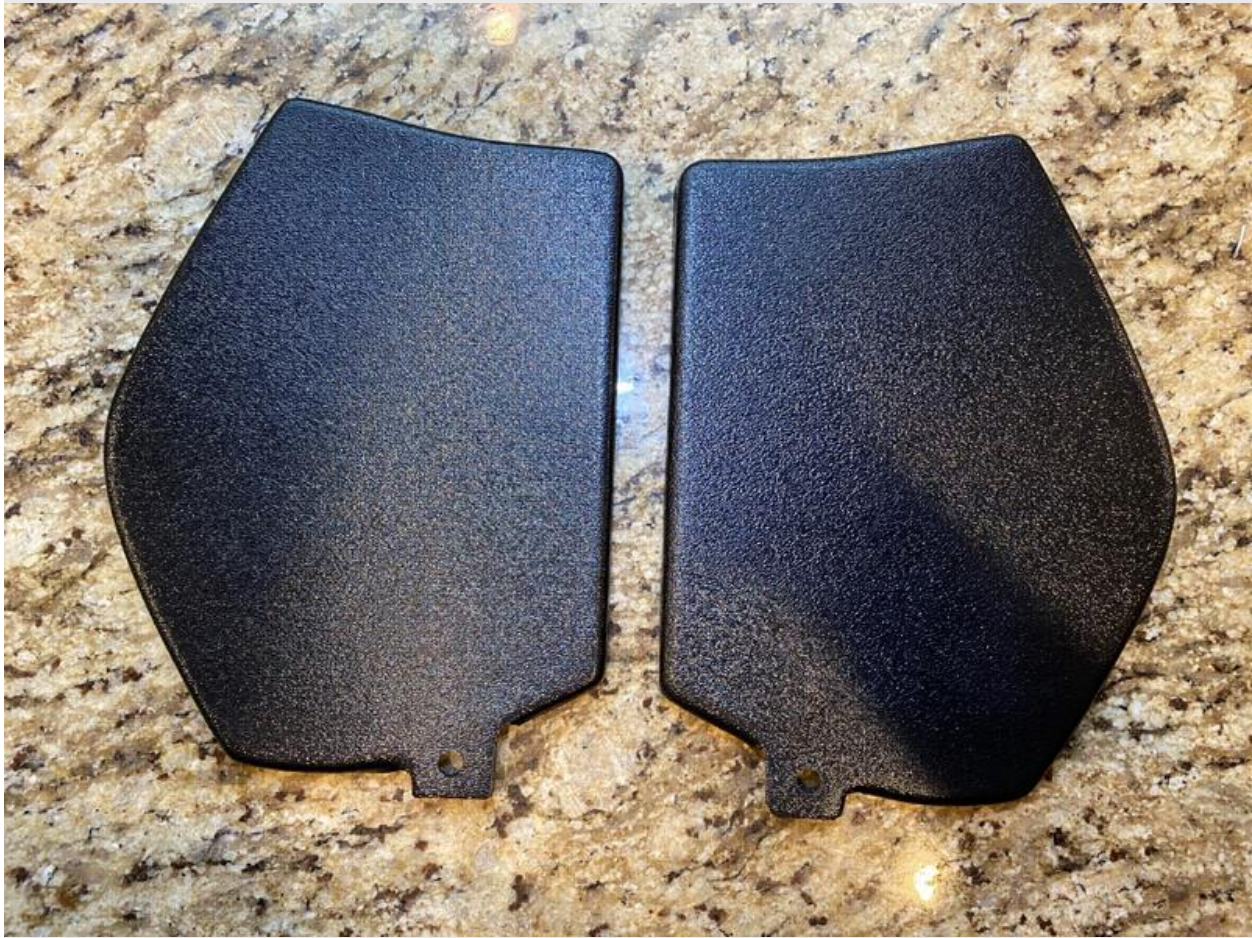
The following image shows the difference between our C8 Strut Tower Covers for vehicles with and without Mag Ride shocks.

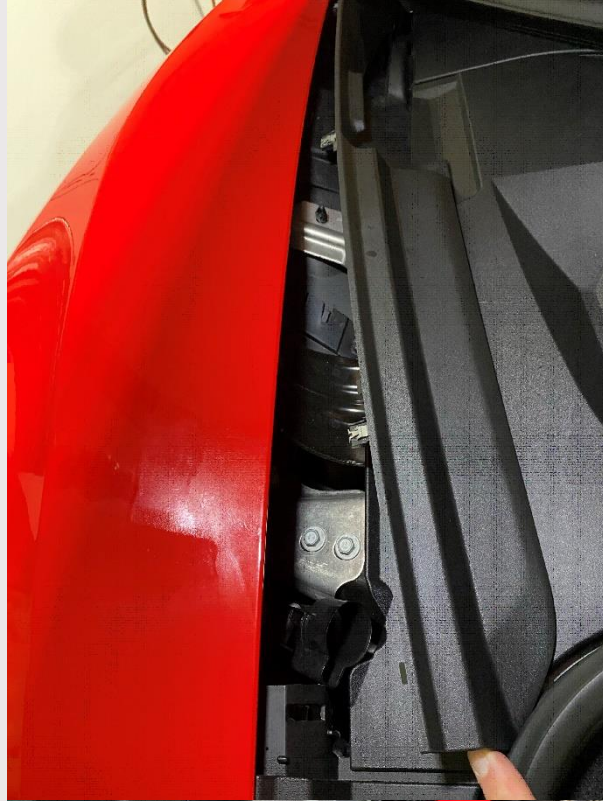
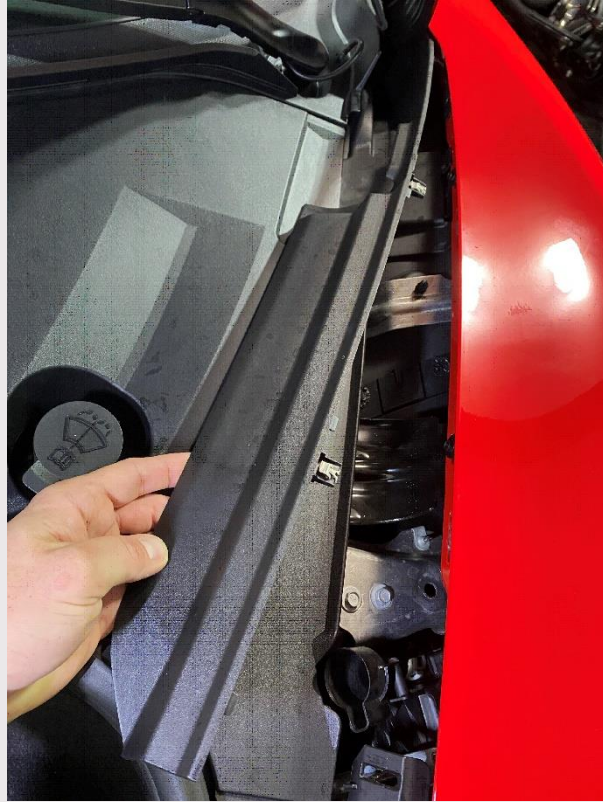
1. Remove the side covers. They are held on with friction clips. To remove the side covers, pull them toward the center of the car.

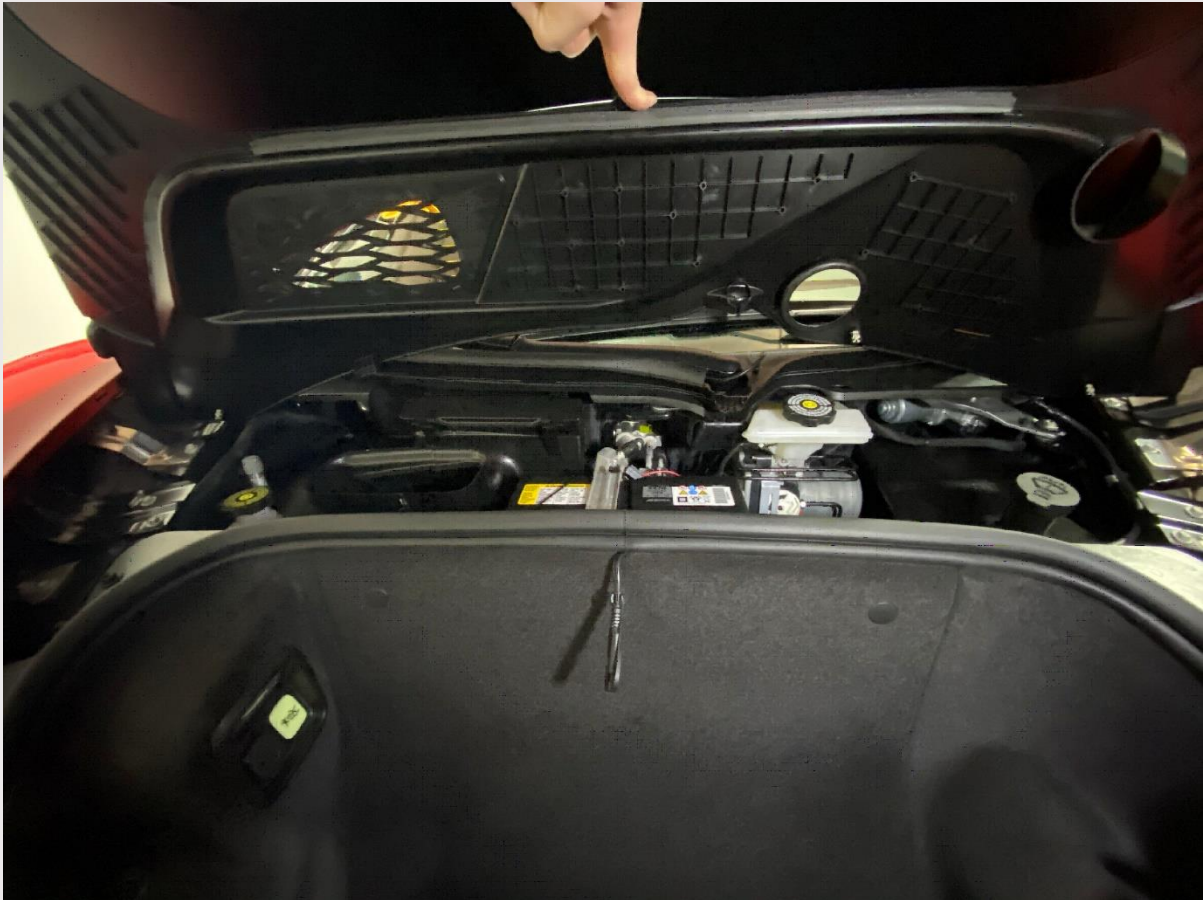
2. Remove the large center cover. Again it is held on with friction clips, pull upward.

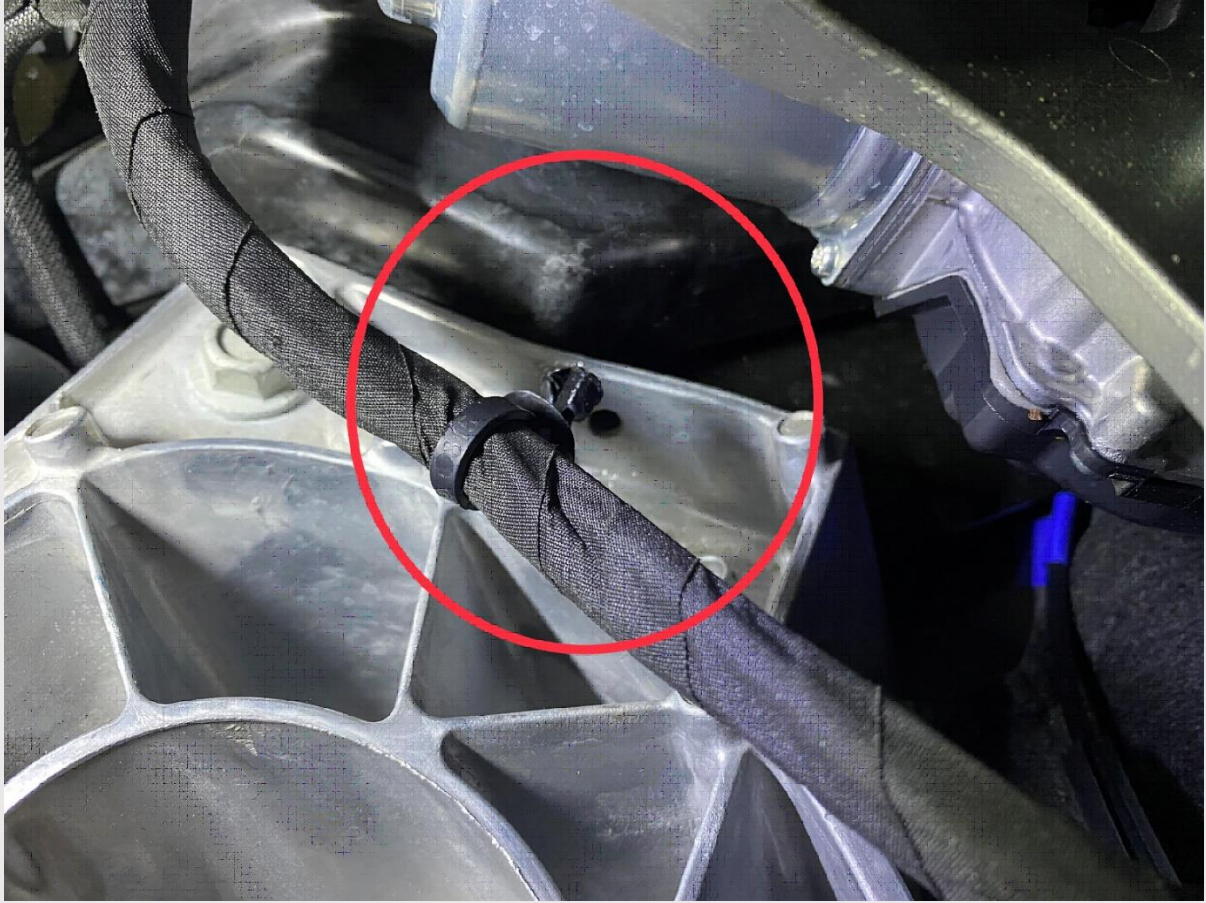
3. Remove the wire loom from the driver's side strut tower using a pry tool.

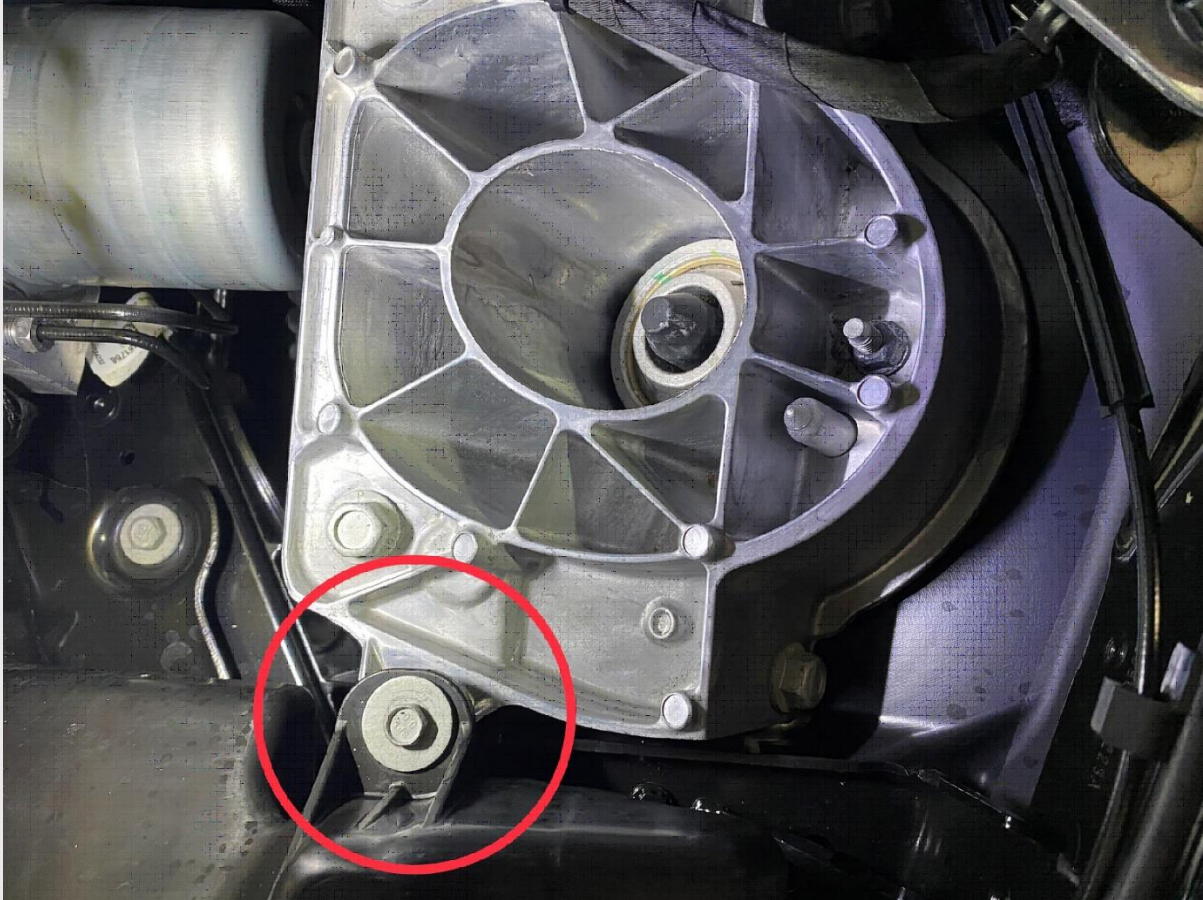
4. Remove the 10mm from the coolant reservoir.

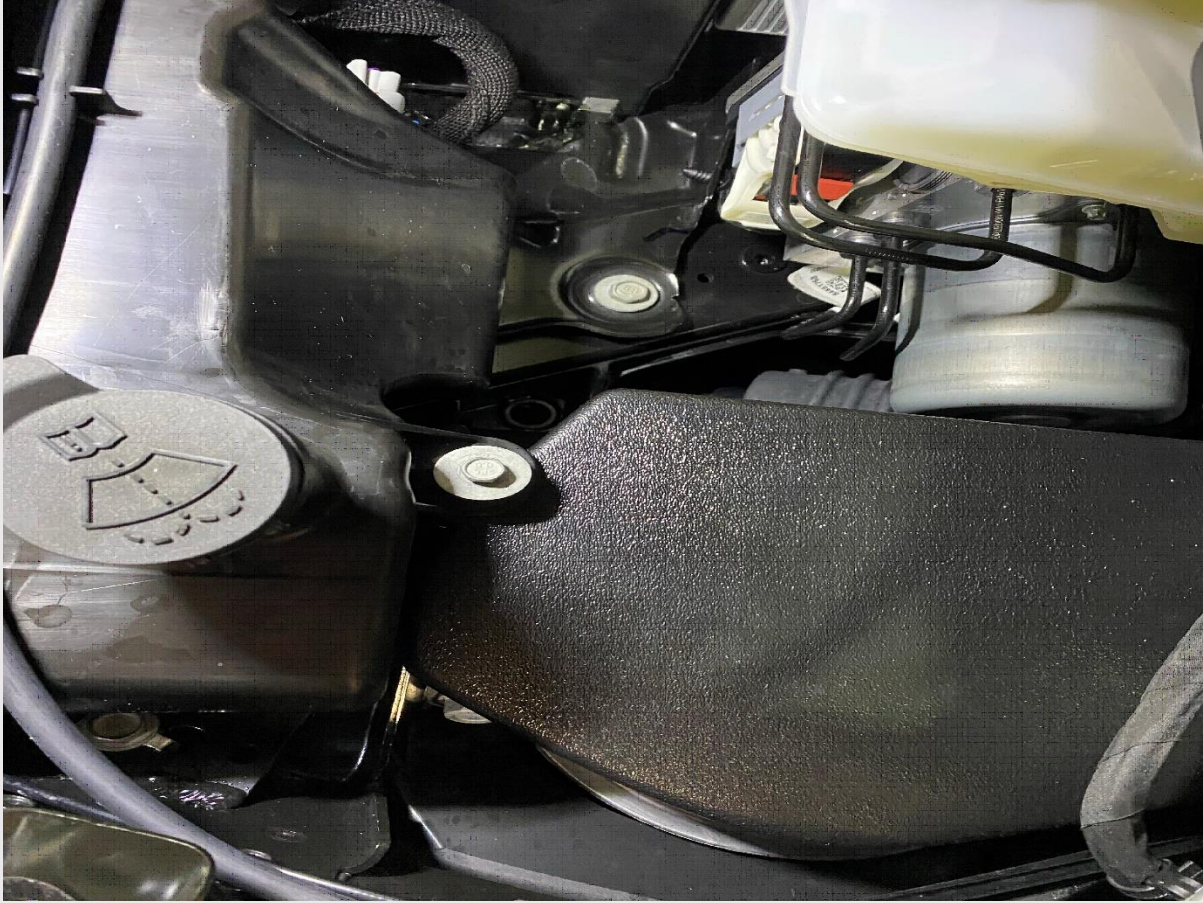
5. Insert strut tower cover with the tab between the strut tower and the reservoir. Install bolt and tighten with 10mm socket.

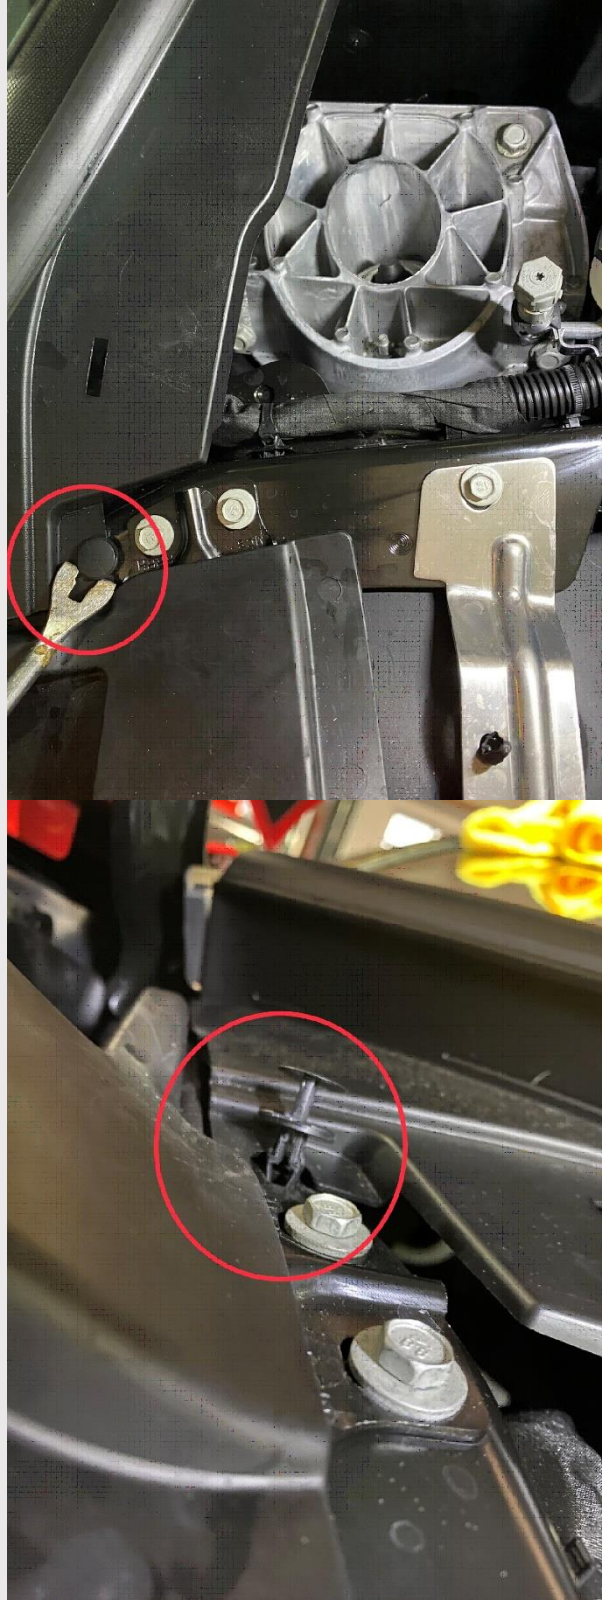
6. Remove the nylon clip (with a pry tool) on the corner of the passenger side trim panel.

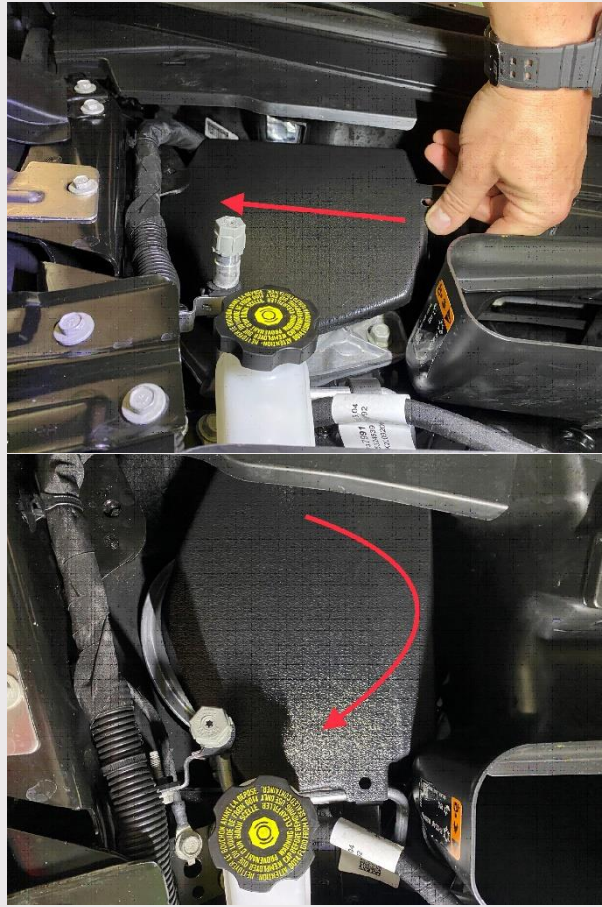
7. Slide the passenger side strut cover into place by angling the cover towards the

outer fender then rotating it into place. Be careful not to bend or damage the hard line or fluid reservoir!

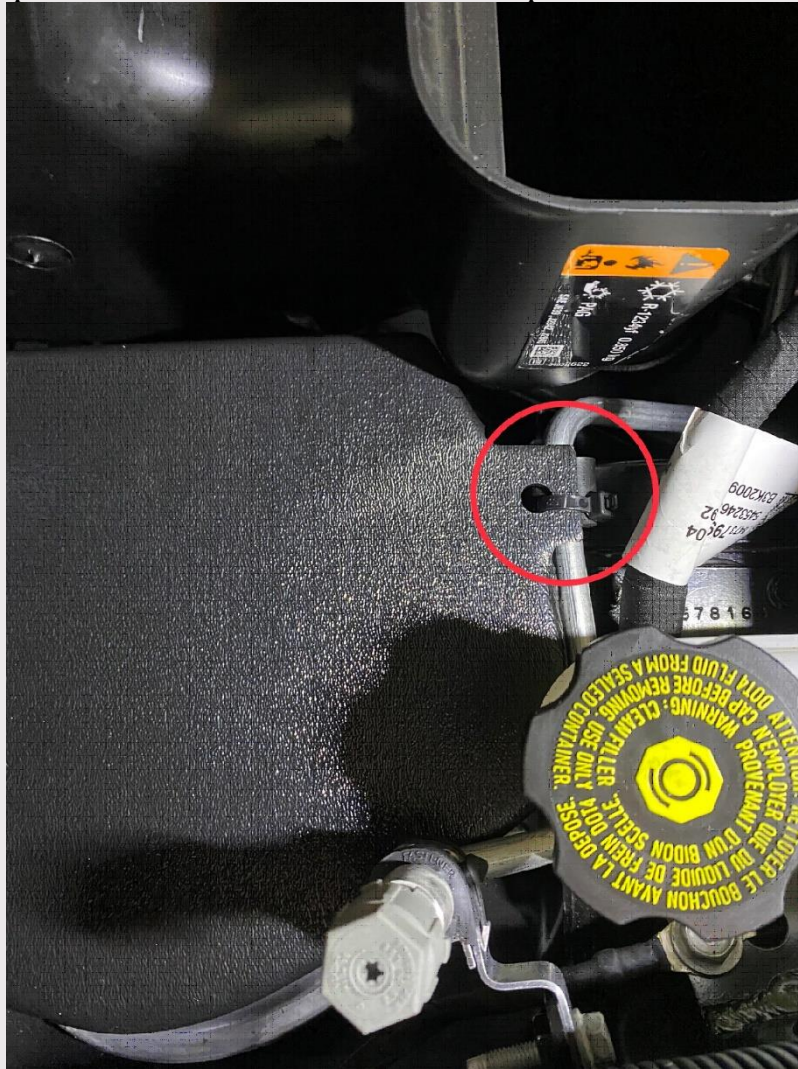
8. Install the zip tie around hard line. Ensure the zip tie is around the rubber isolator.
